8 (1)
AD 73767
MISCELLANEOUS PAPER NO. 4-886

EVALUATION OF THREE-PIECE AM2 ALUMINUM LANDING MAT

Naval Air Engineering Center
Philadelphia, Pennsylvania

U. S. Army Engineer Waterways Experiment Station
CORPS OF ENGINEERS
Vicksburg, Mississippi

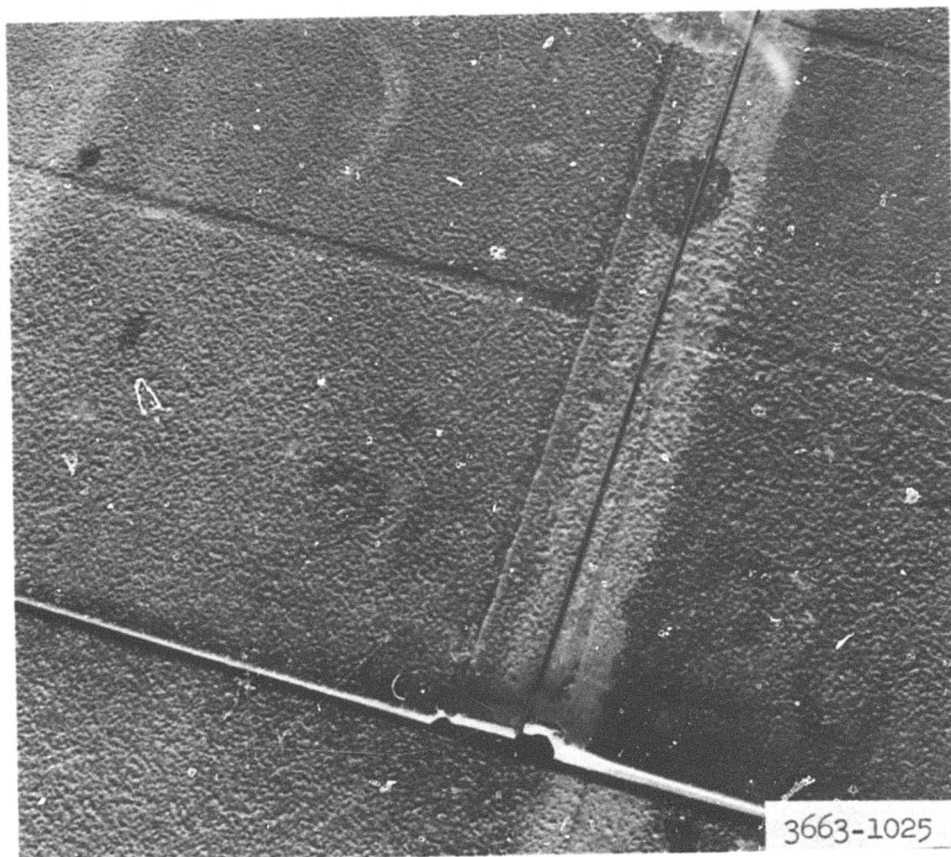
overlapping end-joint connectors were slightly curled due to the planks flexing under traffic (photograph 2). At 20 coverages, small cracks appeared in the end-connector welds of planks 25 and 26 (the end-connector weld joins the end connectors with the extruded portion of the planks). Generally, the item was in excellent condition. After 40 coverages, there were six end-joint weld cracks, three on overlapping and three on underlapping connectors at the ends of abutting planks. The first mat failure occurred at 100 coverages when the end connector separated from the extrusion on plank 29 due to an end-connector weld break on the underside of the plank (photograph 3). Since the end connectors of planks 29 and 30 were locked together, the top skin of plank 29 was torn loose from the longitudinal ribs as the plank deflected under the test load.* Also after 100 coverages it was noticed that there was apparent core damage to four planks in an area on each plank opposite the joint of the preceding run (photograph 5). At this time there were 15 end-connector weld cracks varying in length from 1/2 to 13 in. At 122 coverages, planks 13, 25, and 26 were considered failed owing to an end-connector weld failure such as that shown in photograph 6. Plank 28 also was considered failed because of core damage in the extrusion on the north side of the plank. At 136 coverages, plank 22 failed when the top lip of the underlapping end connector sheared (photograph 7), bringing the number of failed planks to six. The entire section, therefore, was considered failed at 136 coverages. A general view of item 1 at failure is shown in photograph 8. At failure, in addition to the failed planks, there were 13 end-connector weld cracks, 7 apparent core damage areas, and 4 end curls broken off. The weld cracks averaged approximately 5 in. in length. As shown in photograph 8, a slight amount of lateral shifting of the planks

Photograph 2.
Overlapping
end-joint con-
nector curl,
item 1, lane 1

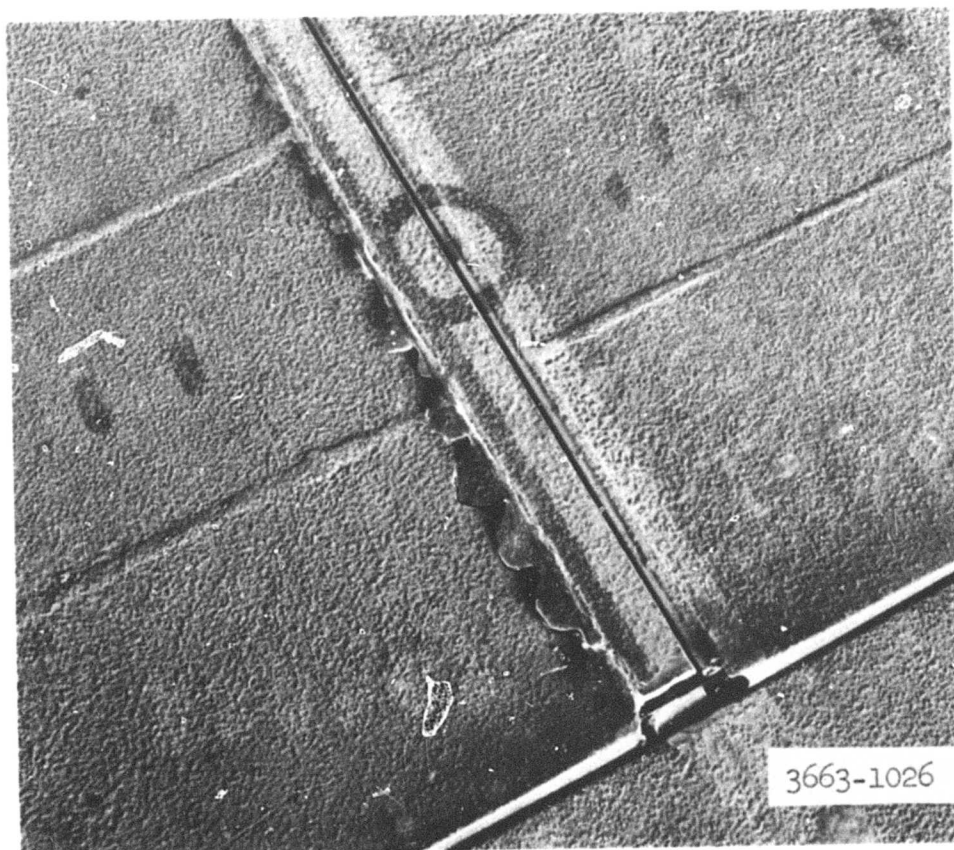
* Obviously, it is impossible to detect a crack in a weld in the bottom of a plank during trafficking until some type of breakage appears on the top side of the mat. In the case of plank 29, the top end-connector weld was stronger than the skin since the failure was evidenced by a skin tear. In other cases it is quite possible that what is detected as a weld crack on top of the end connector is a result of a prior failure in the weld directly below the crack. In any case, complete separation of the end connector from the extrusion must be preceded by a failure on both the top and bottom of the plank (photograph 4).

Photograph 3.
End-connector
weld failure
on underside
of mat re-
sulting in
top skin tear,
item 1, lane 1

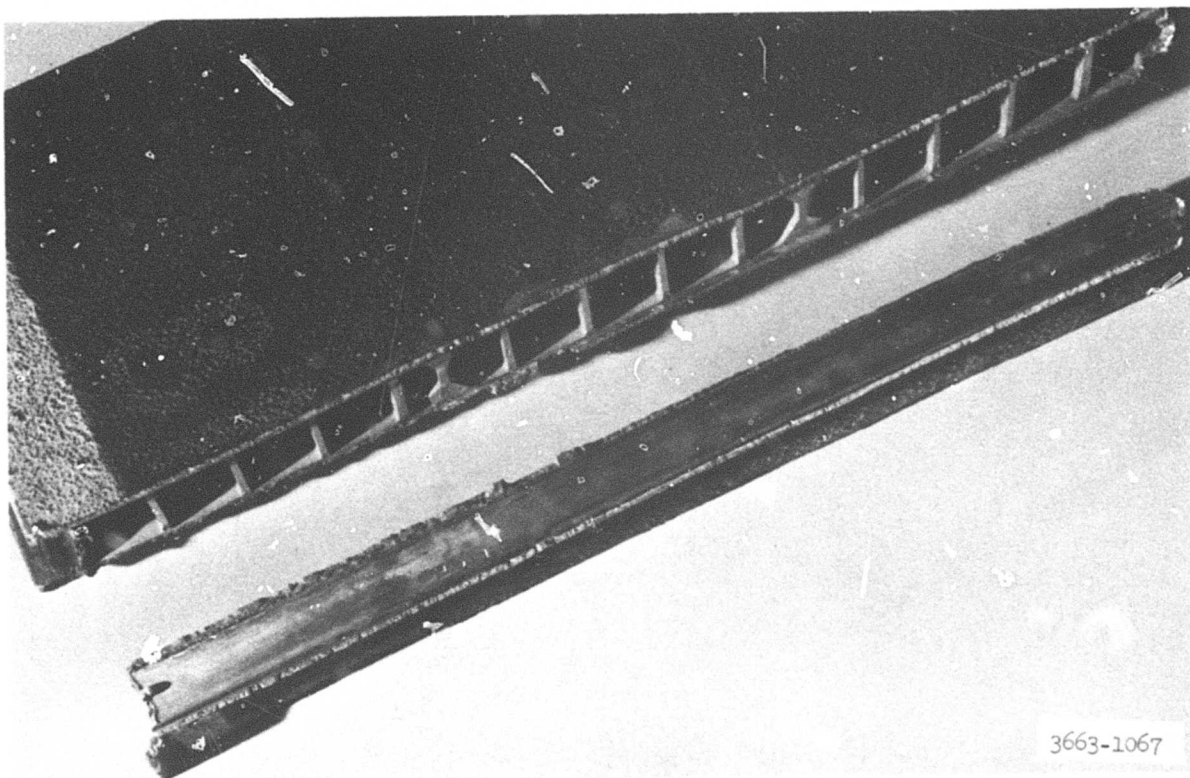
Photograph 4. Complete separation of end connector and extrusion,
item 1, lane 1

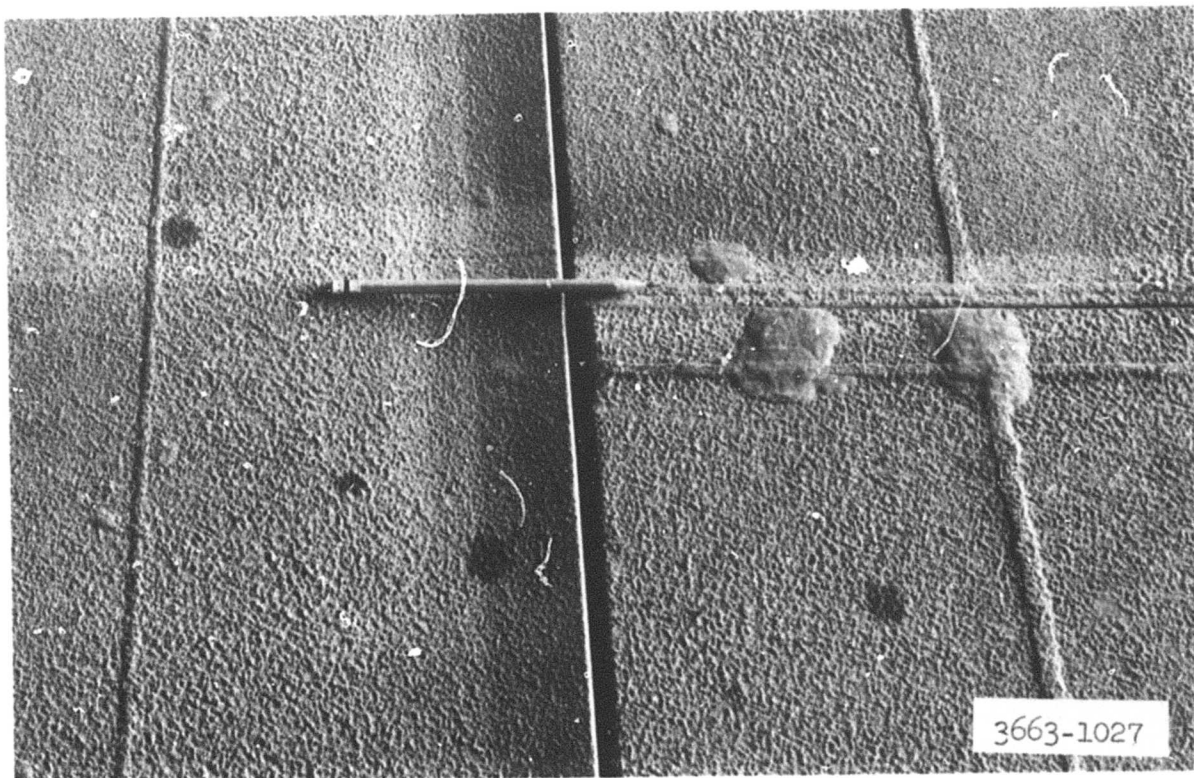
38. All core failures in lane 1 were located in an area of the plank adjacent to the joint of the preceding run and were caused by joint failure and subsequent deflection which resulted in the core's sustaining the impact of the load wheel. As can be seen in photograph 29, the core failure was limited to the extrusion nearest the joint. It should be noted that all failures and breaks which occurred during uniform-coverage traffic were located at or adjacent to an end joint.

Photograph 5. Core damage opposite end joint, item 1, lane 1

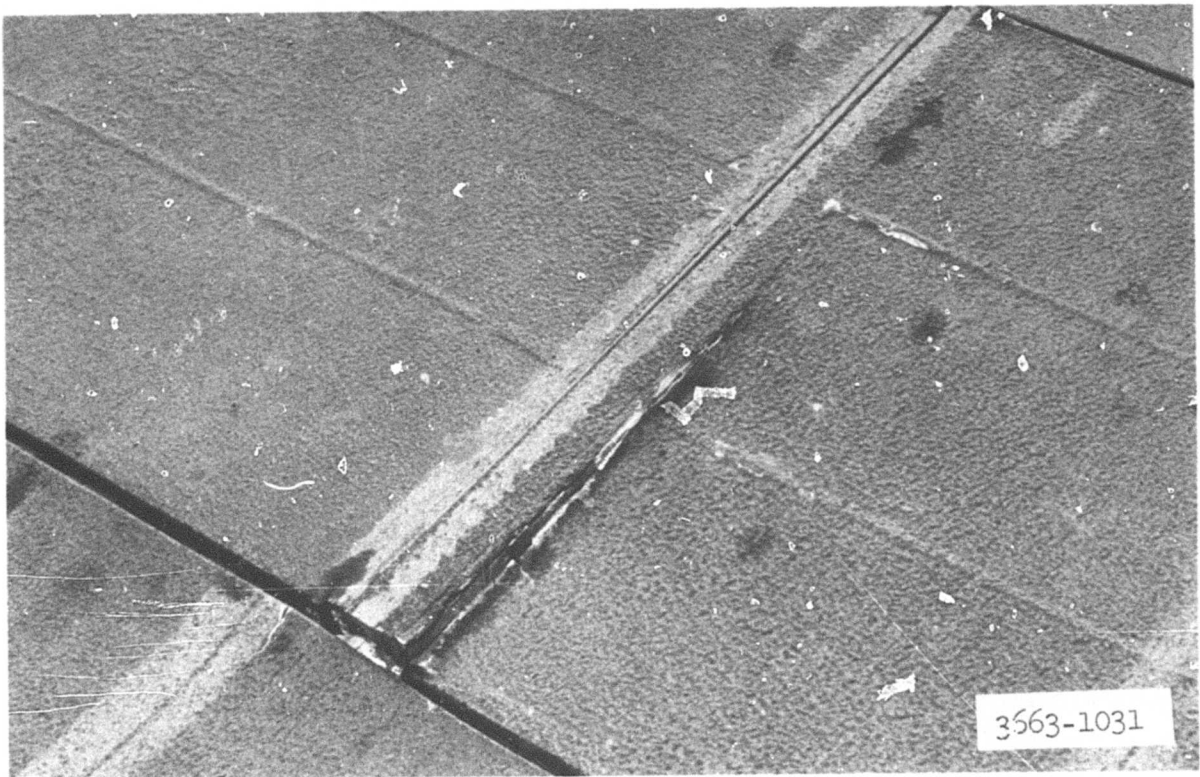
Photograph 6. End joint weld failure, item 1, lane 1

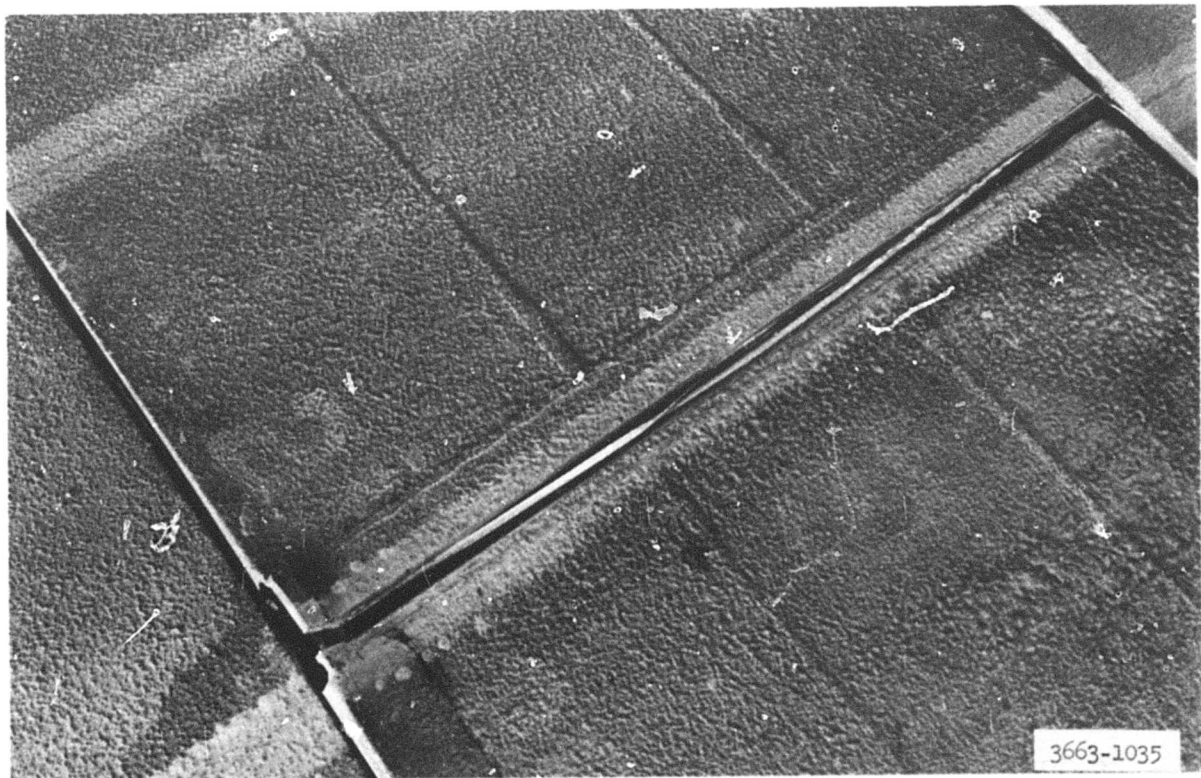
Photograph 7. Failure of top lip of underlapping end connector,
item 1, lane 1

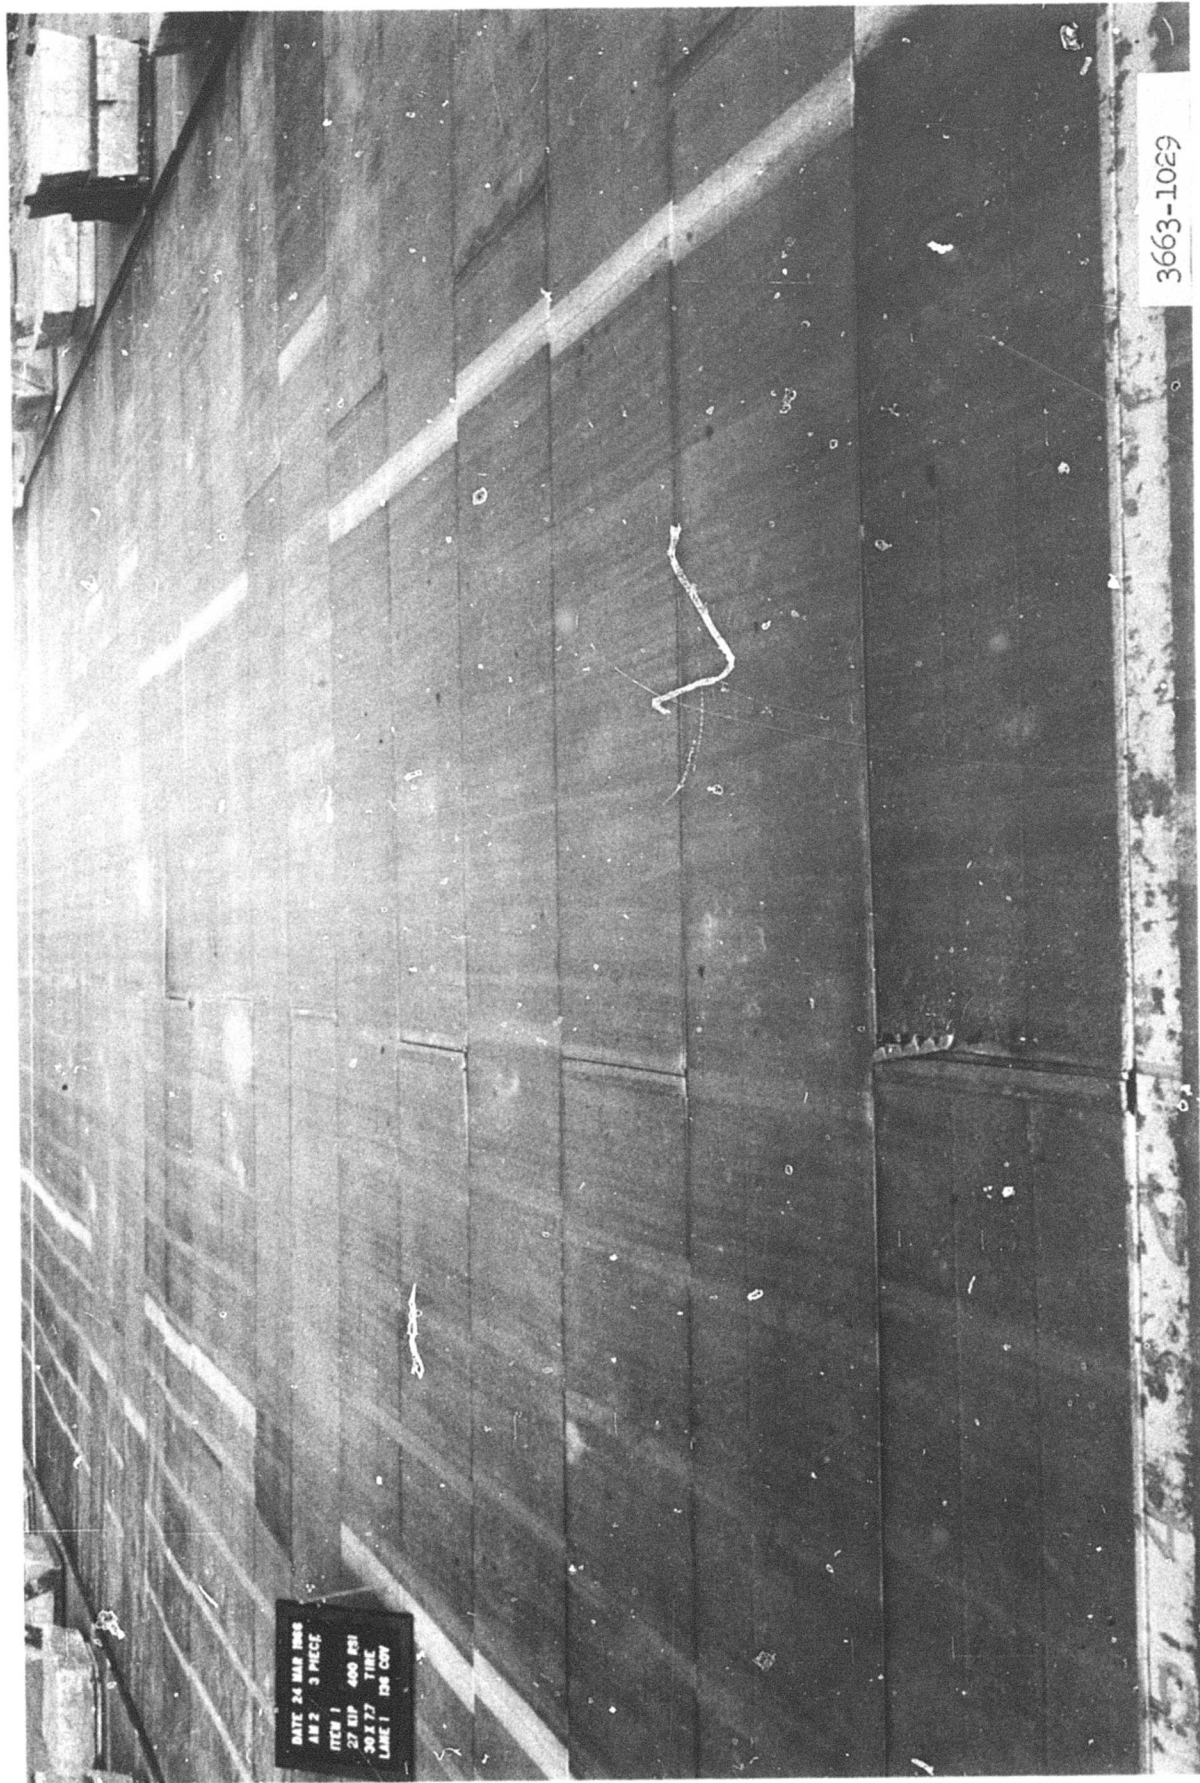
35. As can be noted in table 2, item 1 failed at 136 coverages, and item 2 at 174 coverages, the lower strength item failing first. Both items 3 and 4 withstood 188 coverages of traffic without failure. Although item 2 failed 38 coverages after item 1, there was a similarity in performance of the two items. In both, there was a multiplank failure at 122 coverages which brought the total number of planks failed in each item at that time to five. In each item, there were three overlapping, end-connector weld failures, one underlapping, end-connector weld failure, one core failure, and one end-connector lip failure. At failure, however, there were almost twice as many mat breaks in item 1 as in item 2 (including 6 failed panels in each item).

Photograph 8. Item 1, lane 1, at 136 coverages (failure)

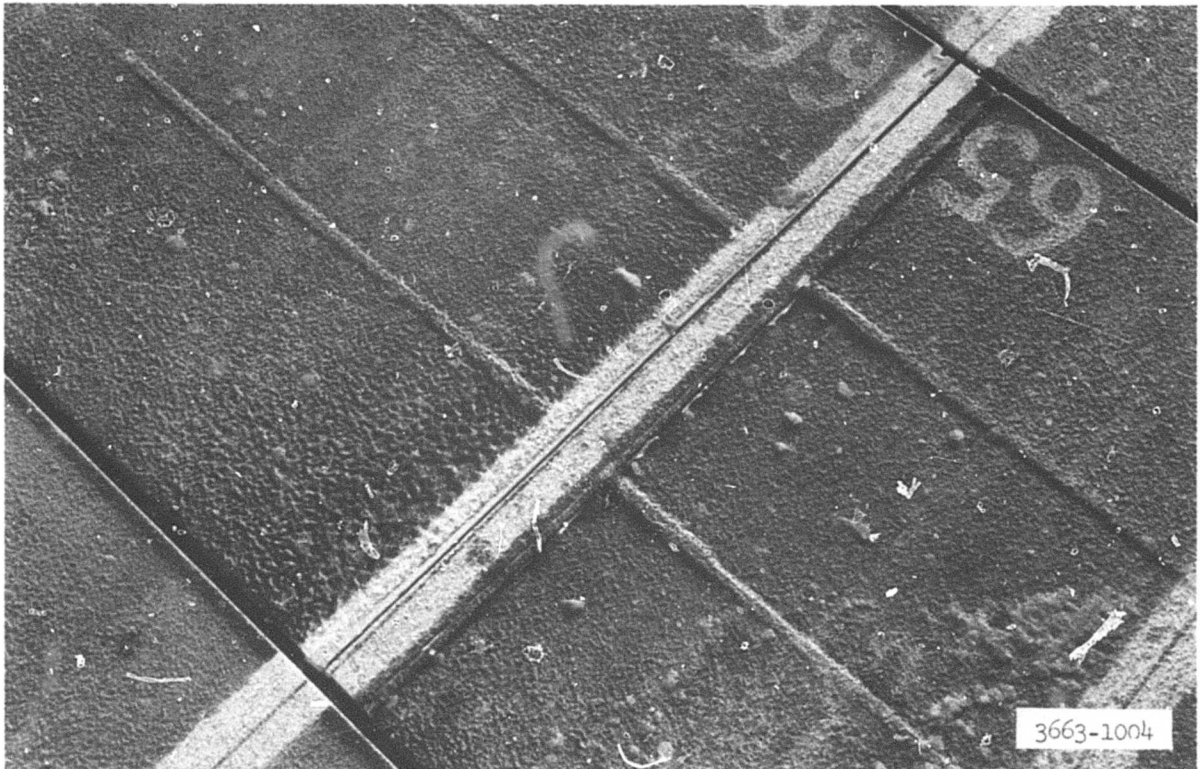
Photograph 10. End-connector weld crack in plank 6, after 20 coverages,
item 2, lane 1

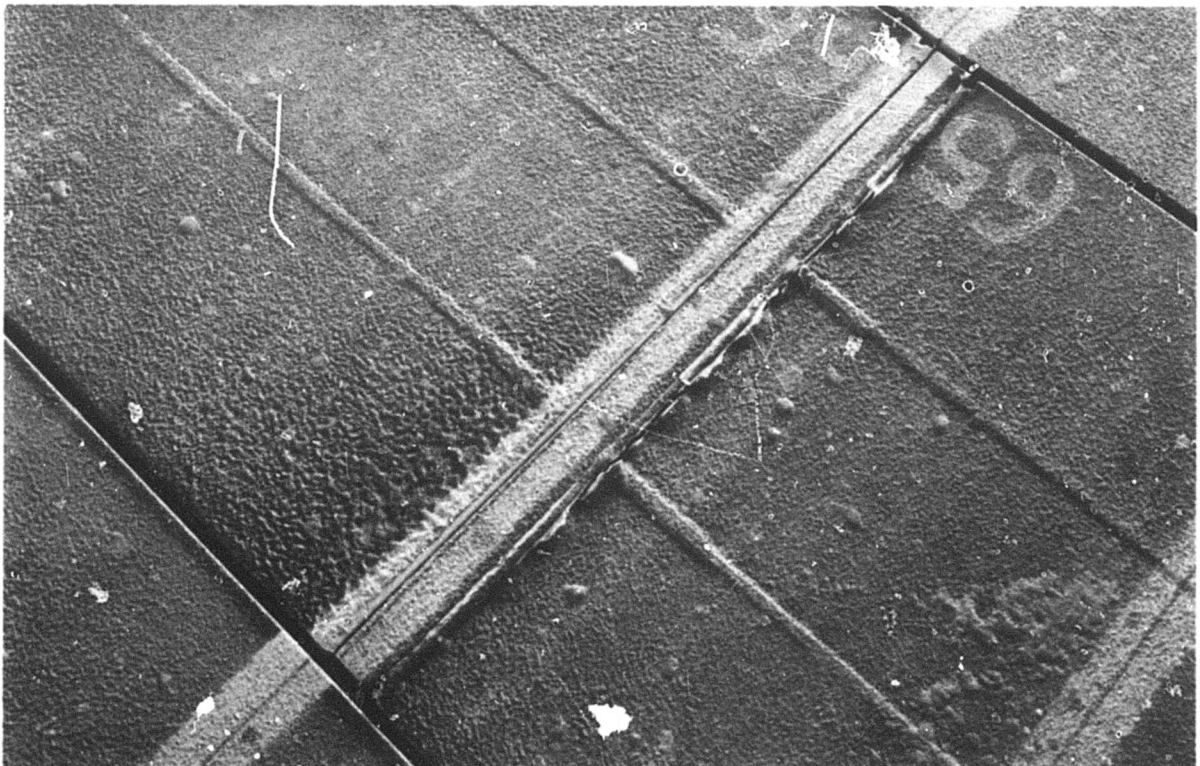
22. Item 2. A general view of item 2 prior to traffic is shown in photograph 9. After four coverages, a small crack had developed in the end-connector weld of plank 65, and after eight coverages, small cracks had occurred in the end-connector welds of two additional planks. At 20 coverages, the weld break in plank 65 had progressed almost entirely across the plank (photograph 10), but no new breaks had occurred in the item, which was in excellent condition. After 40 coverages of traffic, the end-connector weld of plank 65 sheared off completely and the plank was considered failed (see photograph 11). At 100 coverages of traffic, plank 74 failed owing to end-connector weld failure. At this time, there were 10 weld breaks (in addition to the two failures) ranging in length from 1/2 to 18 in. Generally the item was in good condition. At 122 coverages, plank 77 failed because of end-connector weld failure, and plank 78 failed when the upper lip on the underlapping end connector sheared. Also, plank 80, which was adjacent to planks 77 and 78, failed at this time owing to core breakage in a localized area opposite the joint of planks 77 and 78. Traffic was continued to 174 coverages, at which time plank 45 failed through end-connector weld failure. This brought the total number of failed planks to six, and item 2 was considered failed. No new weld cracks had occurred from 100 to 174 coverages. A general view of item 2 at failure is shown in photograph 12. The end-connector weld breaks averaged approximately 6 in. in length at failure. As can be seen in photograph 12, some lateral shifting of the planks had occurred during traffic.

Photograph 11. Complete failure of end-connector weld in plank 65
after 40 coverages, item 2, lane 1

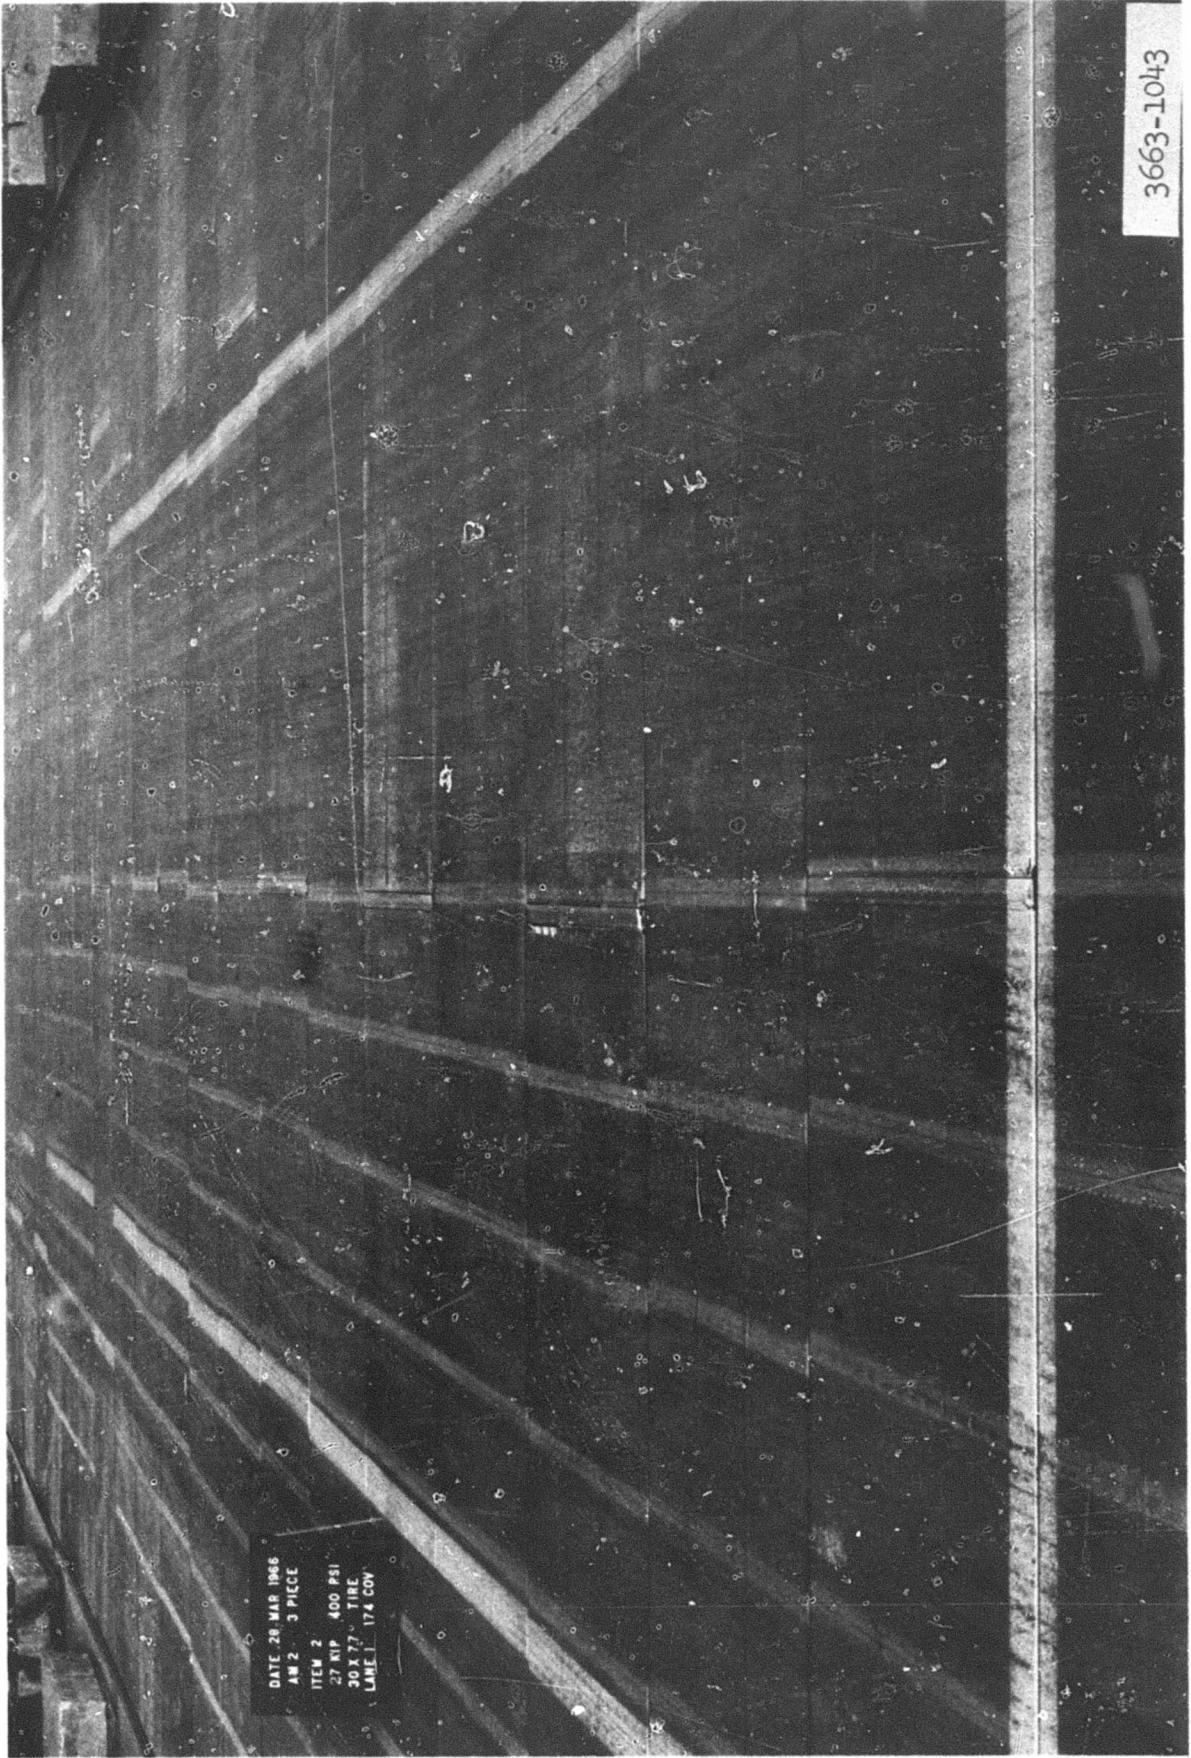
Photograph 12. General view of item 2, lane 1, at 174 coverages (failure)

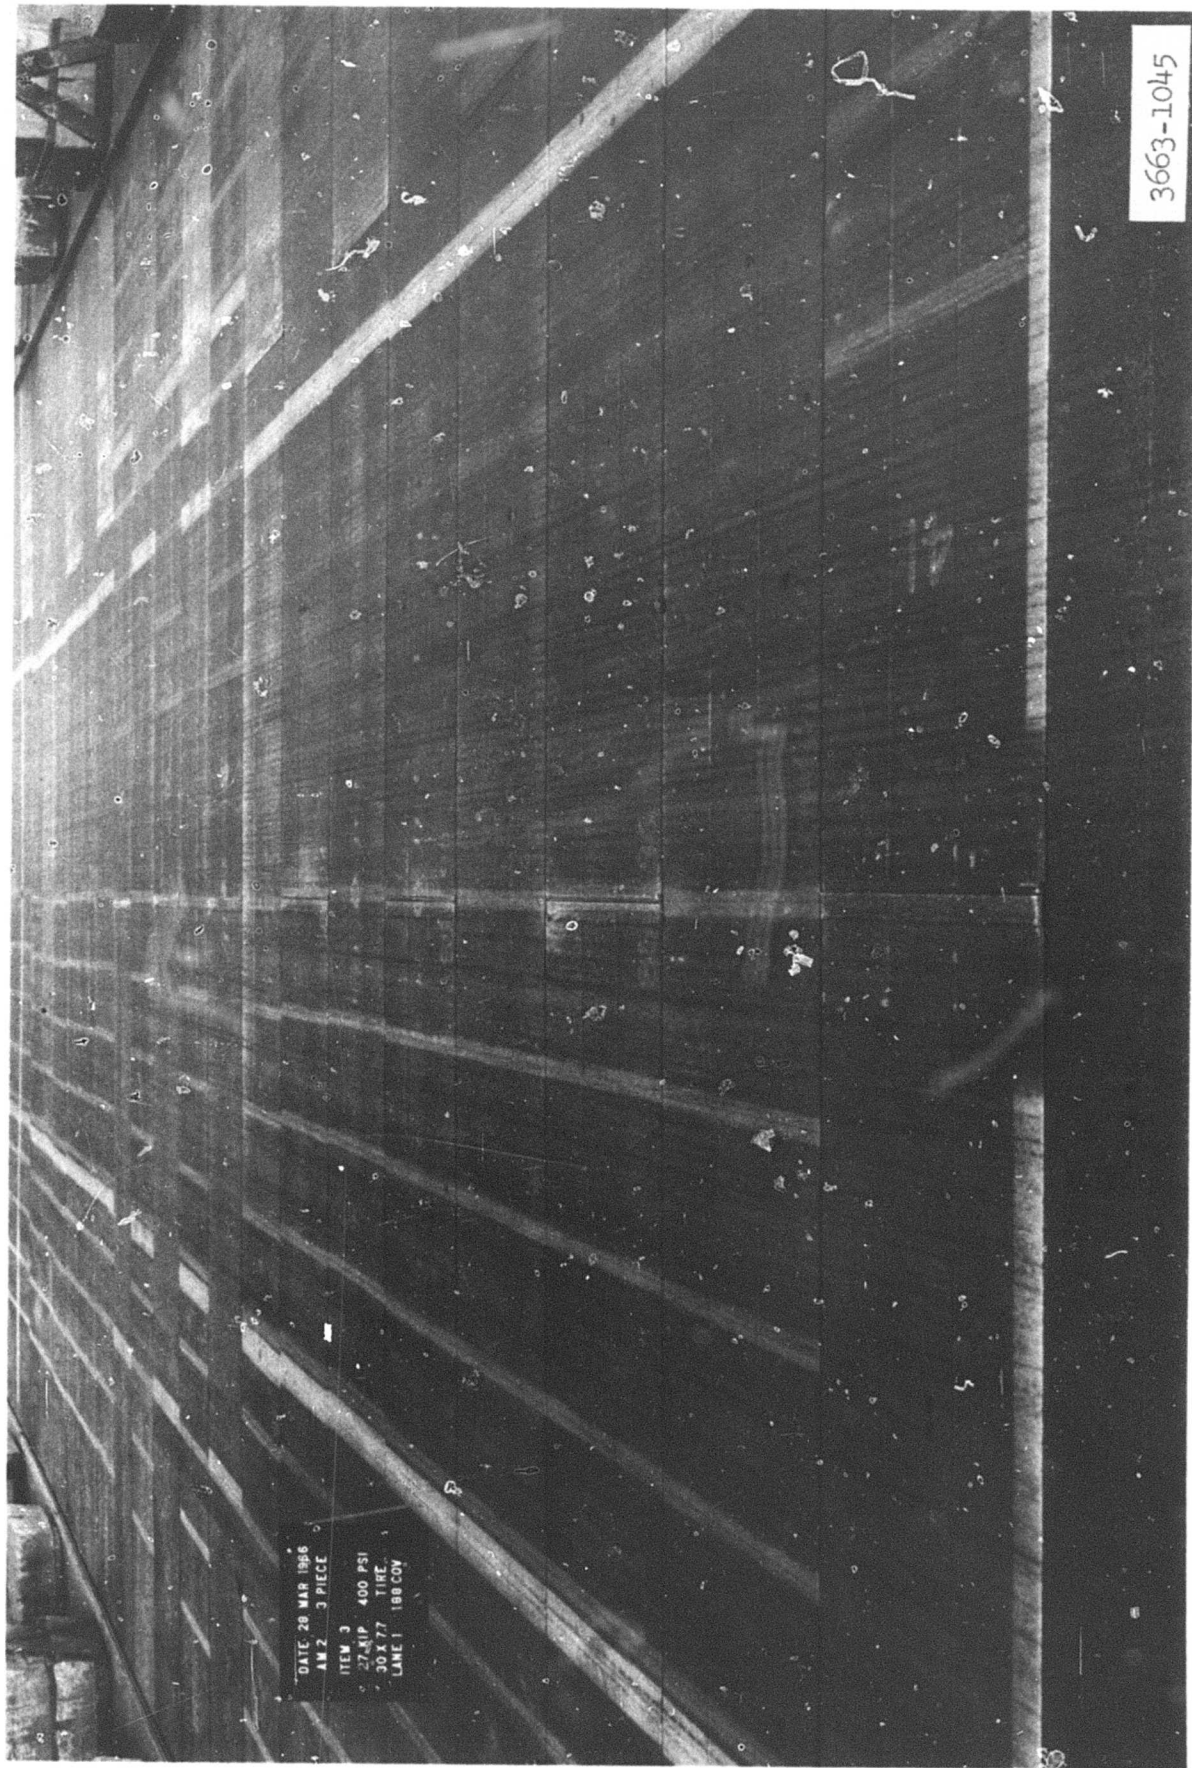
planks 98, 102, and 106 failed from end-connector weld failure. At 188 coverages, traffic was stopped with the item in serviceable condition (photograph 14). At 188 coverages, there were seven end-connector weld cracks which averaged 9 in. in length.

Photograph 14. Item 3, lane 1, after 188 coverages

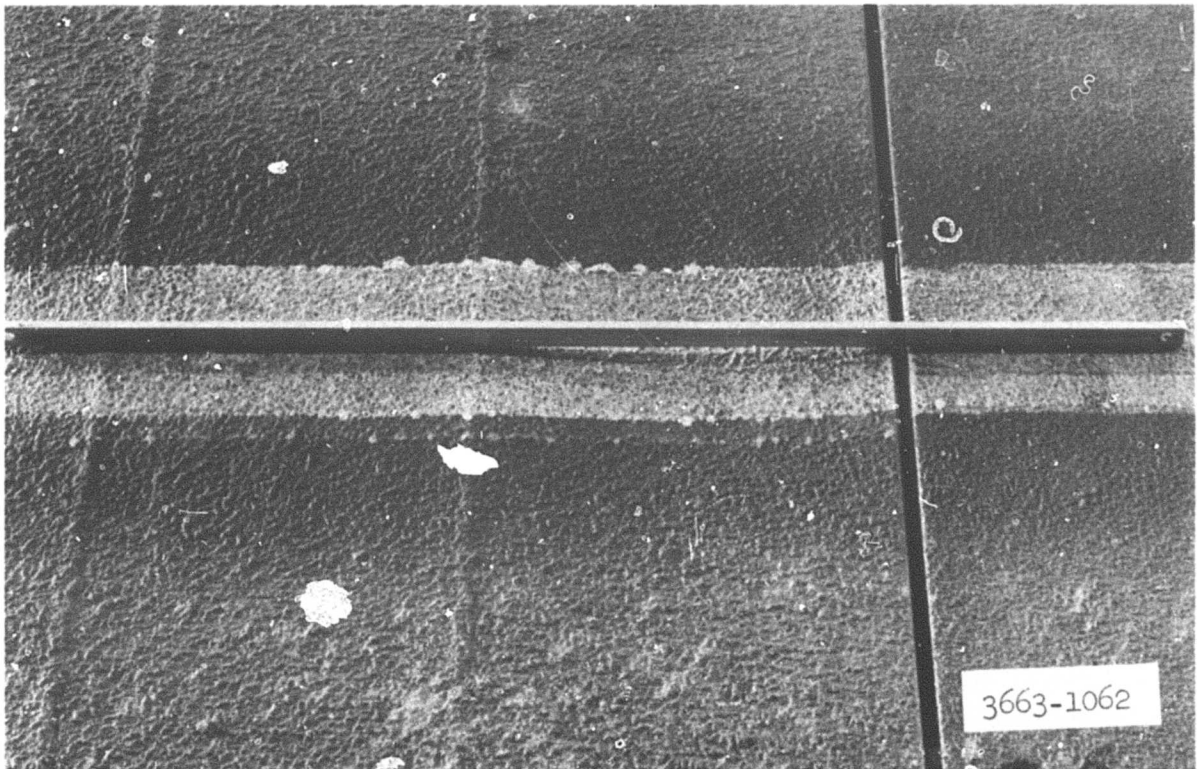
Photograph 18. Dishing in surface as result of core damage,
item 1, lane 2

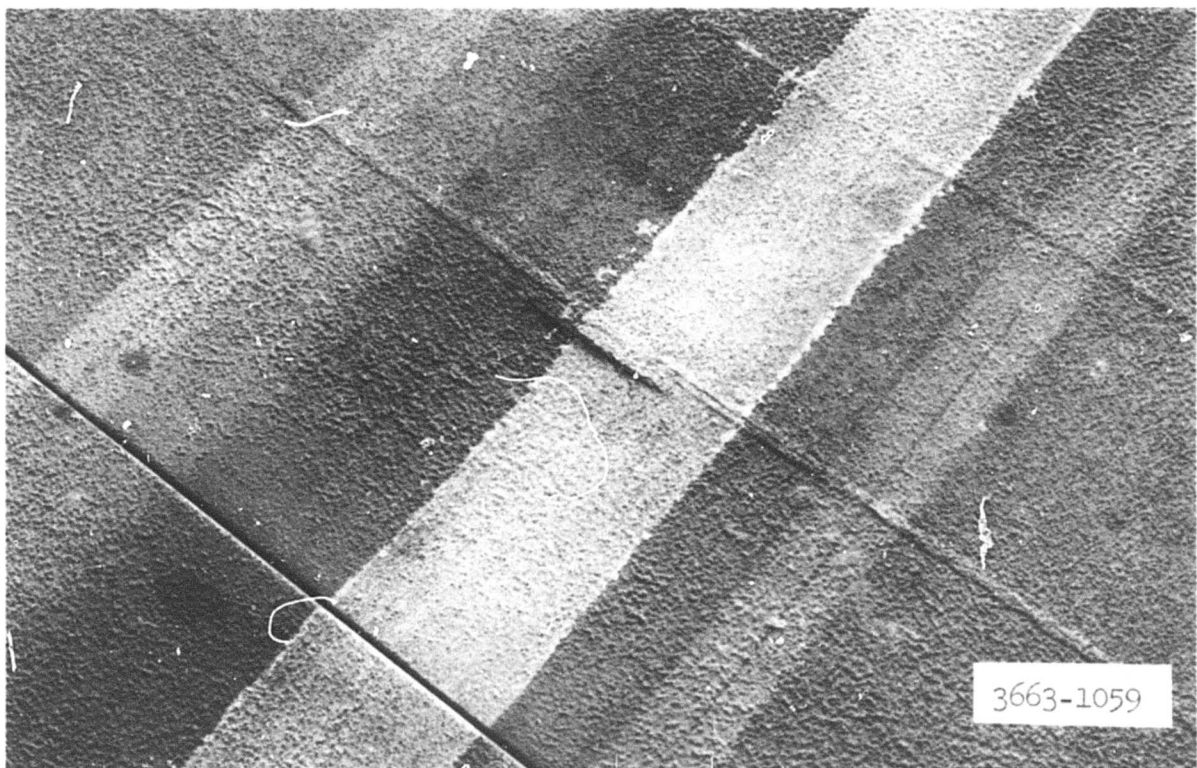
Photograph 19. Skin tear in plank 5 after 1000 passes,
item 1, lane 2

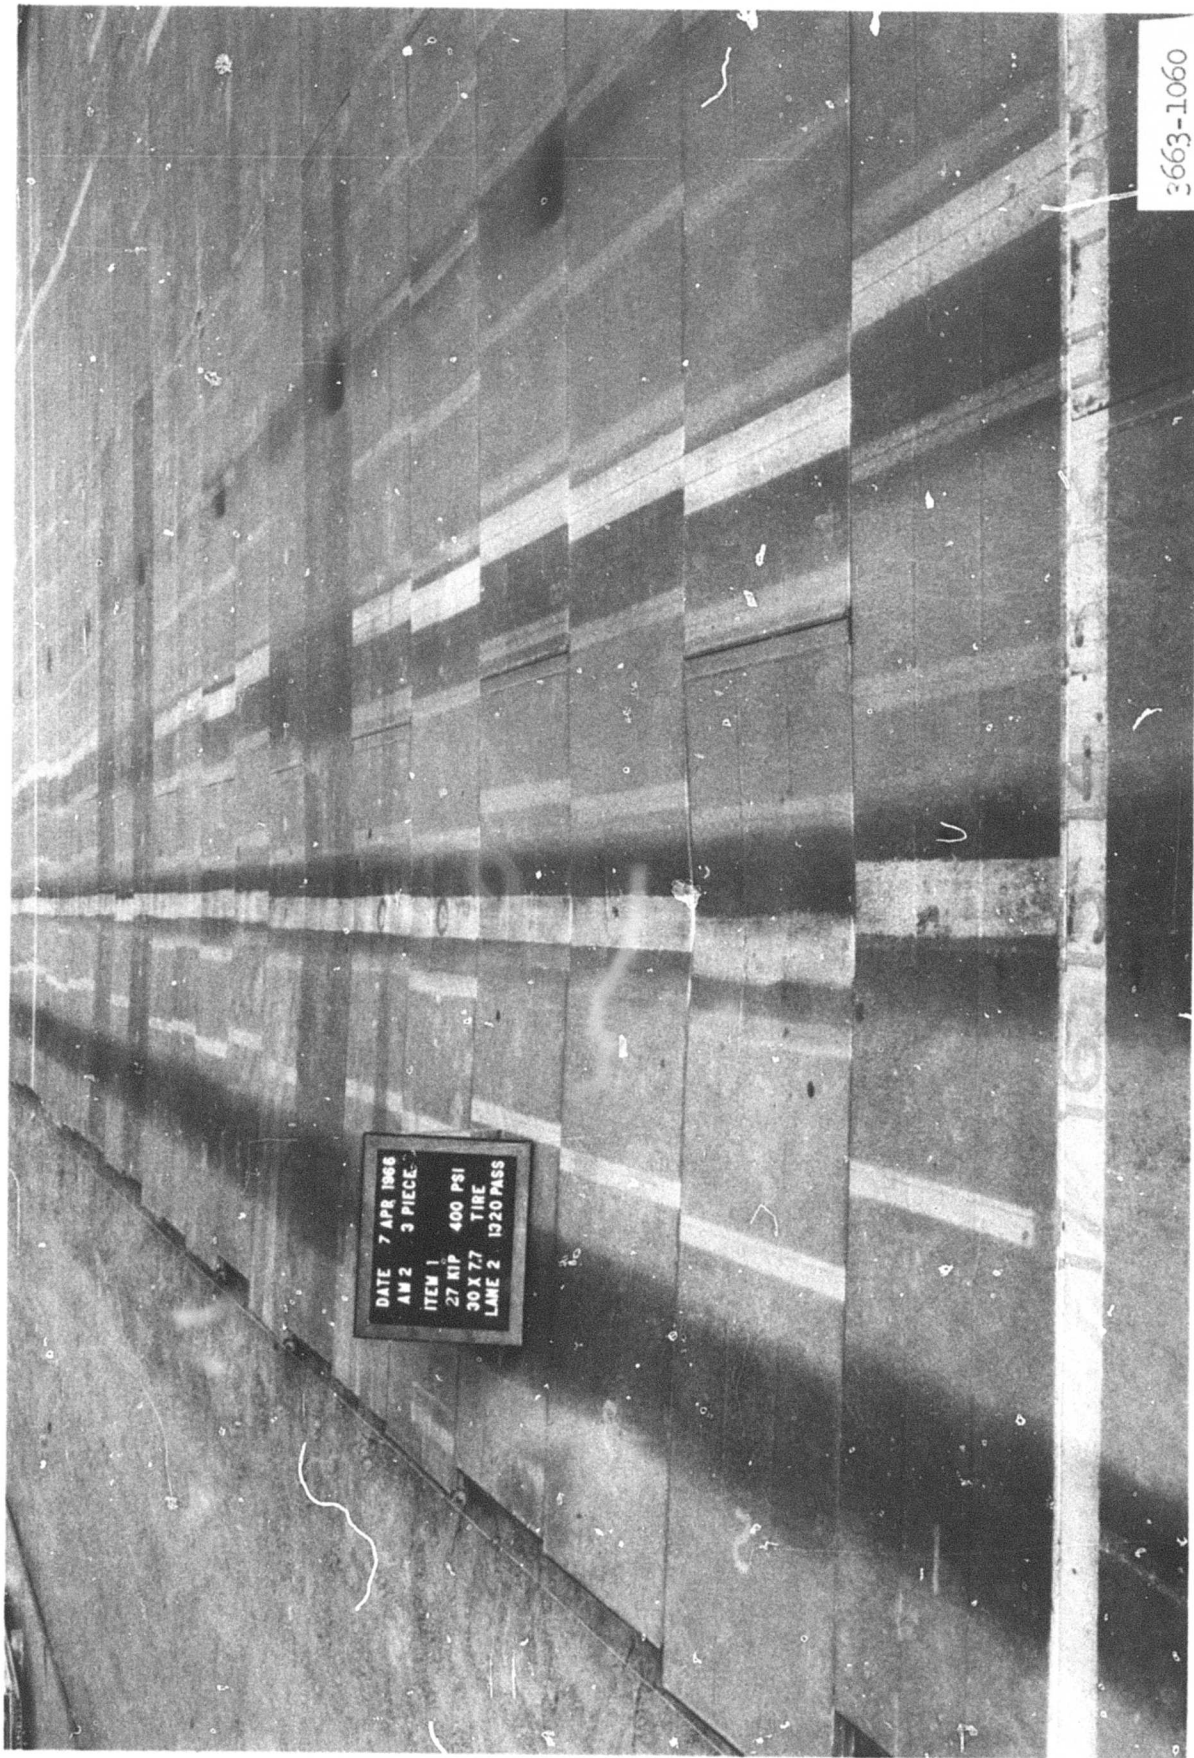
42. Item 1 failed at 1320 passes with six planks failed and six additional areas of apparent core damage. In item 2, there were 16 areas of apparent core damage when traffic was stopped at 1600 passes. Core damage varied from slight to severe, with almost half of the breaks incipient failures. Since the overall condition of the item was rated poor when traffic was stopped, item 2 was considered to have failed at 1600 passes for purposes of analysis. No damage was observed in item 3, and there was one core break in item 4 when traffic was stopped at the end of 1600 passes.

Photograph 21. Item 1, lane 2, after 1320 passes (failure)

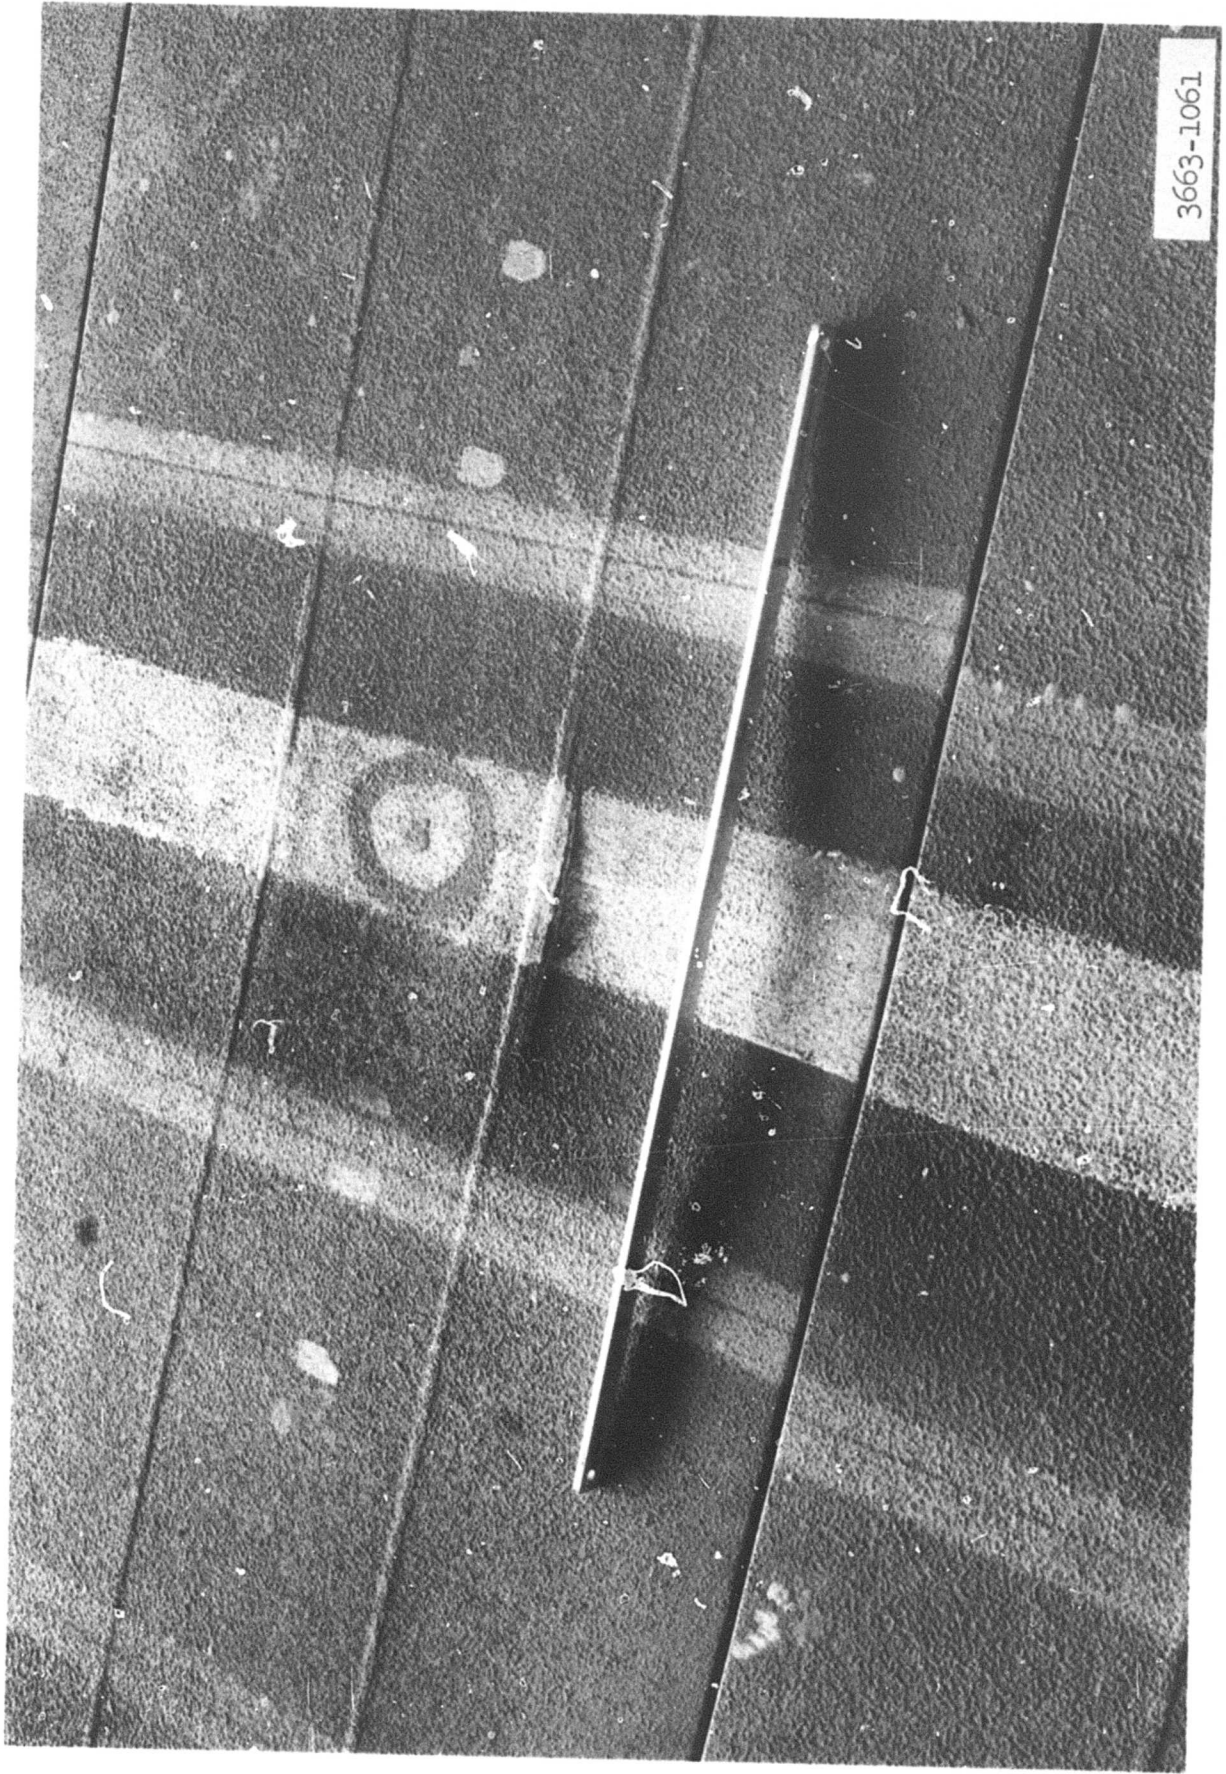
Photograph 23. Skin tear due to core failure, item 2, lane 2
